## Revamping of Billet Reheating Furnace

By changing the design of the roof and combustion system of the 35 tonnes/hr furnace at ISWP, Jamshedpur (a subsidiary of Tata Steel), Encon Thermal Engineers Pvt Ltd (ETPL) was able to achieve a saving of approximately 10 ltr/tonne of furnace oil and increase in production of 5 tonnes/hr, the scale loss has been reduced by 0.5 per cent. The frequent breakdowns due to failure of bull nose have been eradicated. The furnace has been running successfully for more than three years without breakdowns.

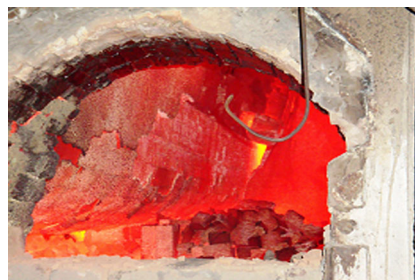
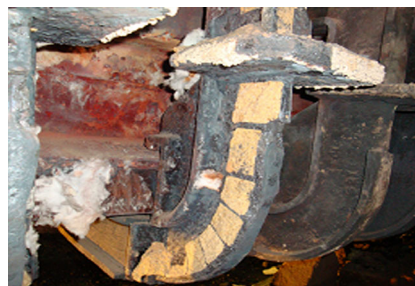
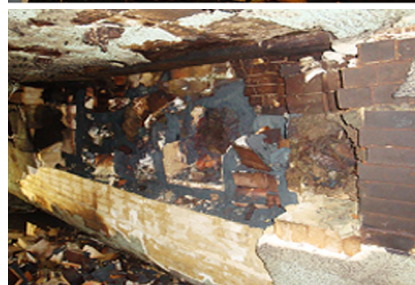
Figure 1: Failure of Bull Nose

The furnace had a Bull Nose design. The bull nose of the furnace was water cooled, over the years the water-cooling of the bull nose was discontinued due to which the clients were facing the following problems:

- Bull nose area furnace refractory bricks were getting damaged was frequently falling, and

- Bull nose area refractory hanging bricks and cast steel hangers were getting burnt.

It was observed that the Bull Nose construction and design were the reasons for majority of the failure. Due to gaps in the bull nose the cast steel hangers, which were holding the refractory bricks, were getting heated quickly, the temperature of the hanger and roof near the bull nose was alarmingly above the standard.

The soaking and heating zone of the furnace were completely redesigned. The bull nose of the furnace was replaced with a camel hump design. Side burners were given in the heating zone instead of top burners. The design of the hanger was changed and state of the art refractory lining was used instead of the conventional lining for the roof.
