## Revamping of Billet Reheating Furnace

By changing the design of the roof and combustion system of the 35 tonnes/hr furnace at ISWP, Jamshedpur (a subsidiary of Tata Steel), Encon Thermal Engineers Pvt Ltd (ETPL) was able to achieve a saving of approximately 10 ltr/tonne of furnace oil and increase in production of 5 tonnes/hr, the scale loss has been reduced by 0.5 per cent. The frequent breakdowns due to failure of bull nose have been eradicated. The furnace has been running successfully for more than three years without breakdowns.

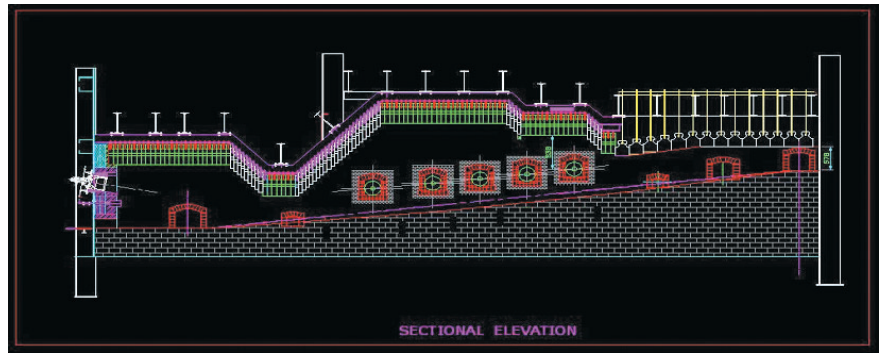
G A Original Design of the Furnace

It was observed that the Bull Nose construction and design were the reasons for majority of the failure. Due to gaps in the bull nose the cast steel hangers, which were holding the refractory bricks, were getting heated quickly, the temperature of the hanger and roof near the bull nose was alarmingly above the standard.

It was observed that the present recuperator is made of plain tubes and was only giving a maximum air pre-heat temperature is 1900°C.

In order to achieve a continuous production of 35-tonnes/hr in the furnace the heat load of the furnace was calculated and found to be insufficient. Heat load of the furnace was increased and

The soaking and heating zone of the furnace were completely redesigned. The bull nose of the furnace was replaced with a camel hump design. Side burners were given in the heating zone instead of top burners. The design of the hanger was changed and state of the art refractory lining was used instead of the conventional lining for the roof.

To increase the firing rate in the furnace Encon high velocity burners of size 4A were used in the sidewalls instead of 4 IIP-Encon 5A burners and 5 IIP-Encon 4A burners on the top of the furnace, the burners in soaking zone remained the same.
